# Debris/Ice/TPS Assessment And Integrated Photographic Analysis For Shuttle Mission STS-46

September 1992

DEBRIS/ICE/TPS ASSESSMENT  
AND  
PHOTOGRAPHIC ANALYSIS  
OF  
SHUTTLE MISSION STS-46

July 31, 1992

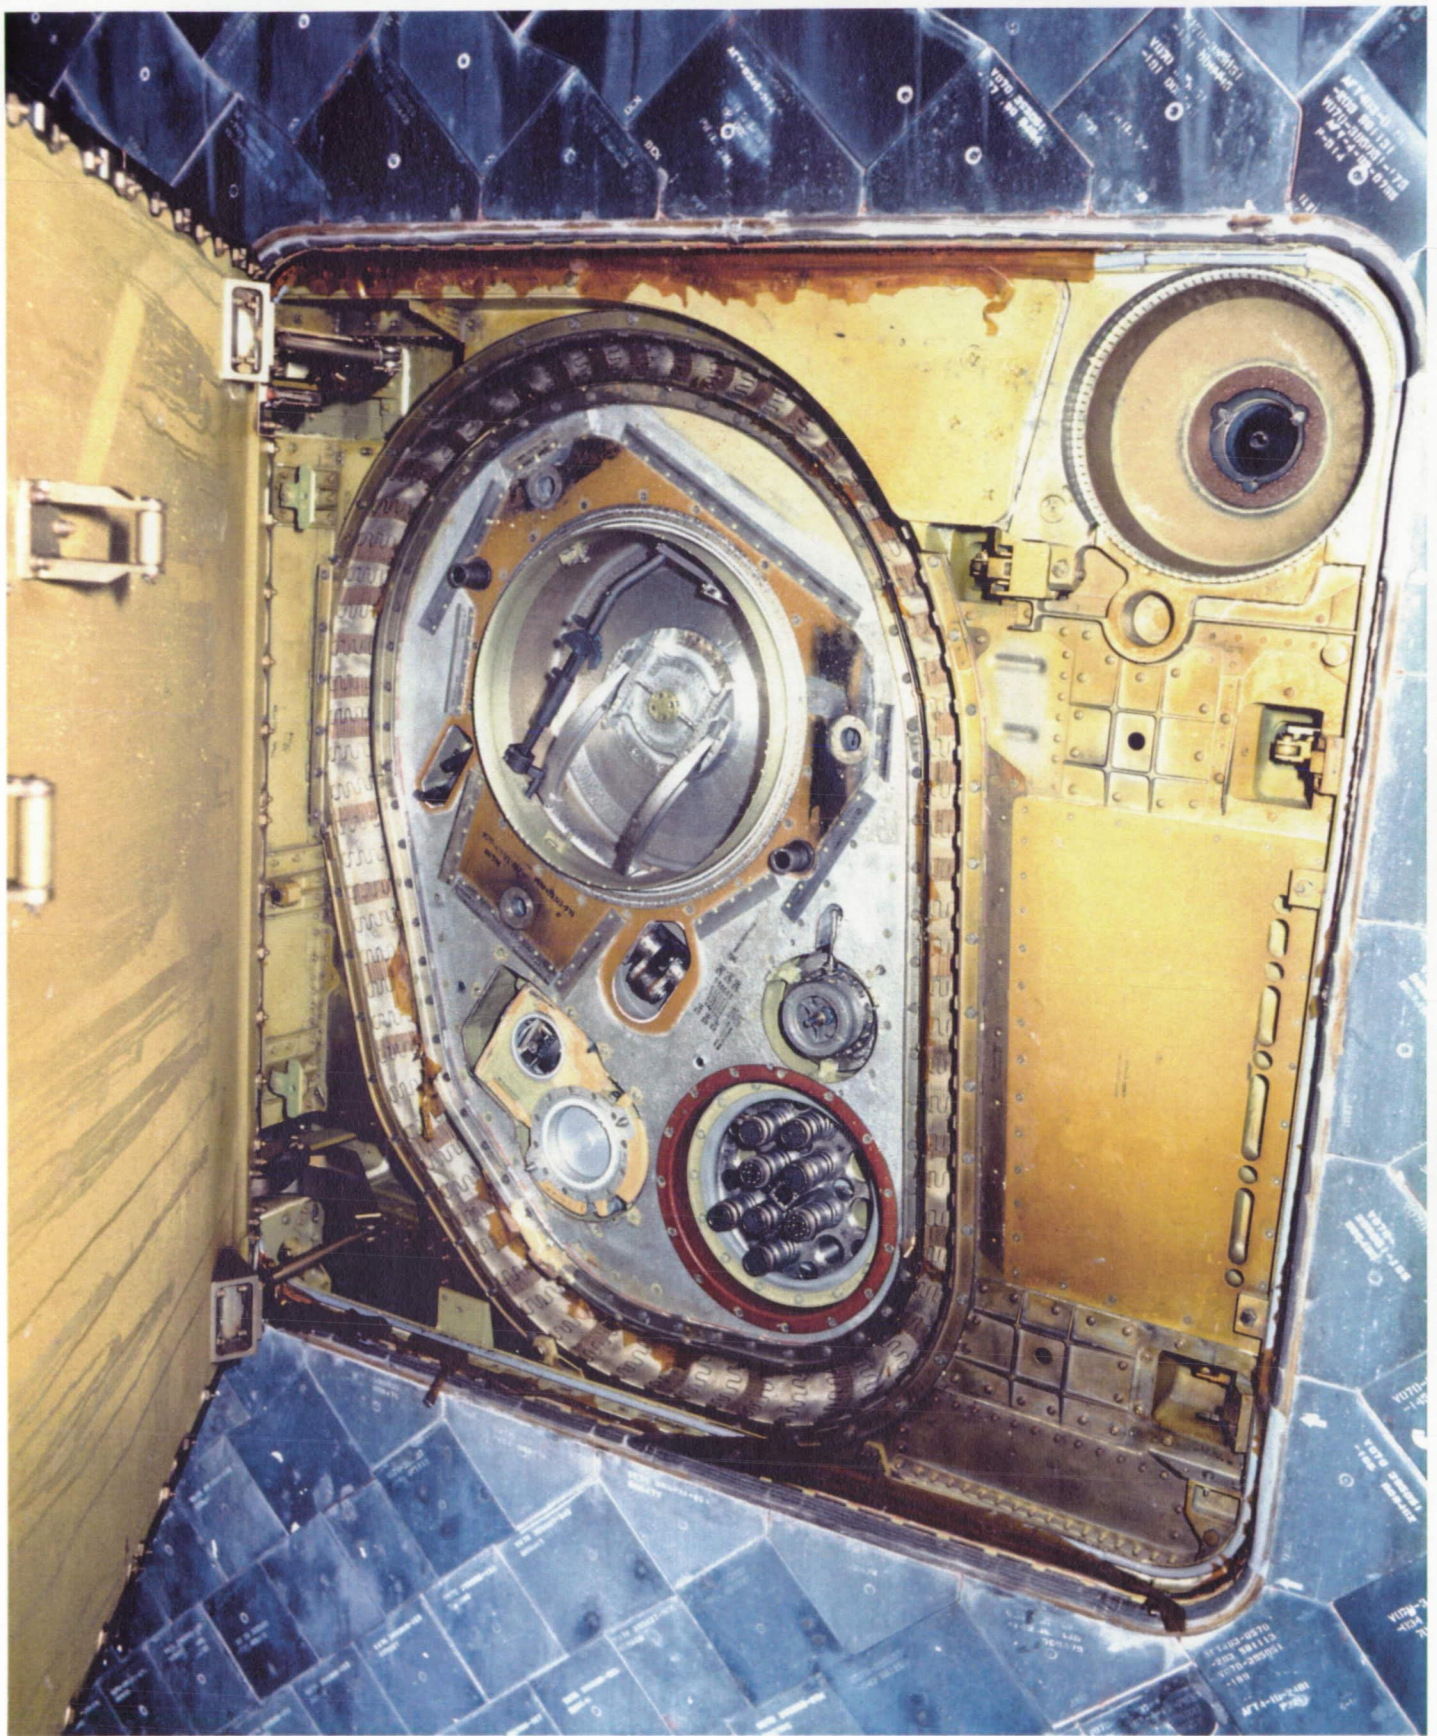
Overall view of the LH2 ET/ORB umbilical. All separation ordnance devices appeared to have functioned properly. No flight hardware was found on the runway below the umbilical when the ET door was opened.

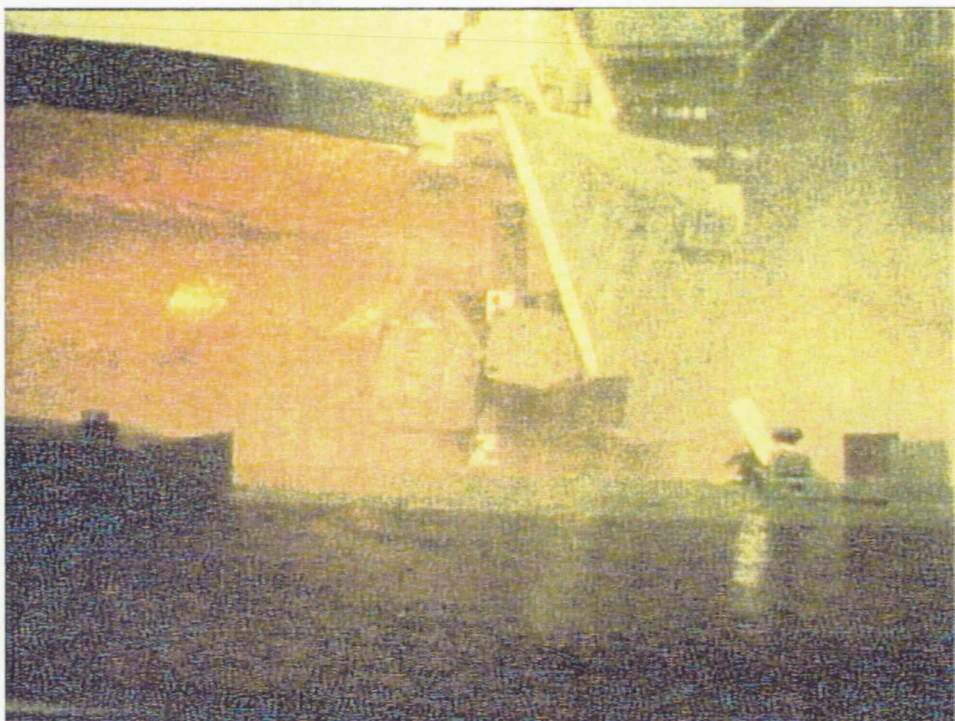
Figure 1

Holddown Post M-7 Stud Hang-up

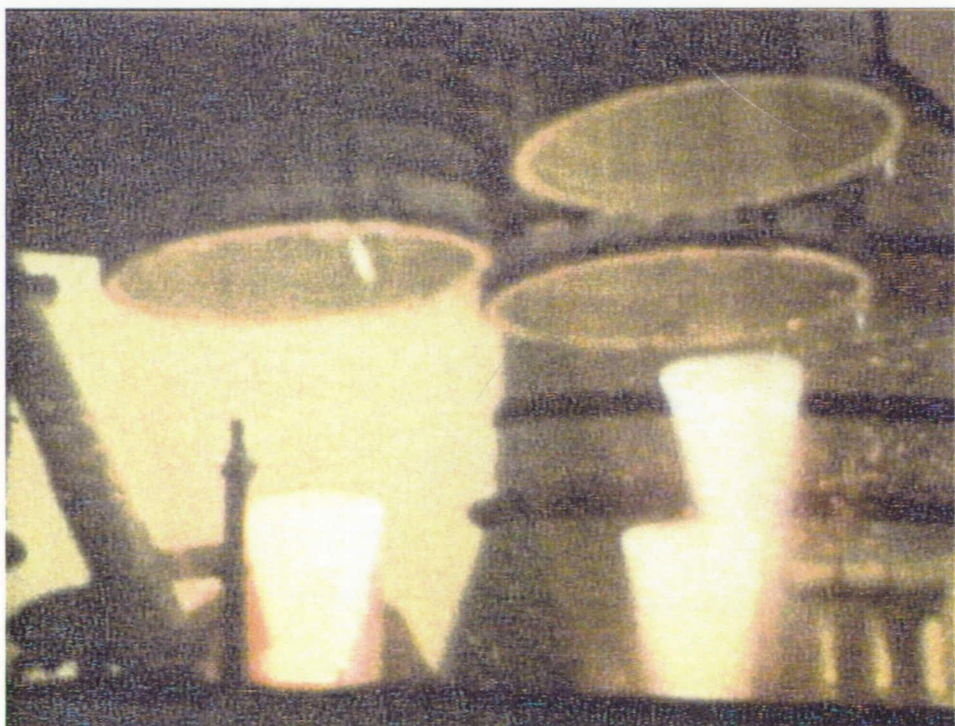
Figure 2

Color Change in SSME Mach Diamond
